DEPARTMENT OF TRANSPORTATION

Quality Assurance and Source Inspection

Contract #: 04-0120F4Cty: SF/Ala Rte: 80 PM: 13.2/13.9File #: 69.28**WELDING INSPECTION REPORT****Resident Engineer:**Pursell, Gary**Address:** 333 Burma Road**City:** Oakland, CA 94607**Report No:** WIR-015820**Date Inspected:** 09-Jul-2010**Project Name:** SAS Superstructure**OSM Arrival Time:** 1900**Prime Contractor:** American Bridge/Fluor Enterprises, a JV**OSM Departure Time:** 700**Contractor:** Zhenhua Port Machinery Company, Ltd (ZPMC), Changxing Island **Location:** Shanghai, China**CWI Name:** See below**CWI Present:** Yes No**Inspected CWI report:** Yes No N/A**Rod Oven in Use:** Yes No N/A**Electrode to specification:** Yes No N/A**Weld Procedures Followed:** Yes No N/A**Qualified Welders:** Yes No N/A**Verified Joint Fit-up:** Yes No N/A**Approved Drawings:** Yes No N/A**Approved WPS:** Yes No N/A**Delayed / Cancelled:** Yes No N/A**Bridge No:** 34-0006**Component:** Tower and OBG Components**Summary of Items Observed:**

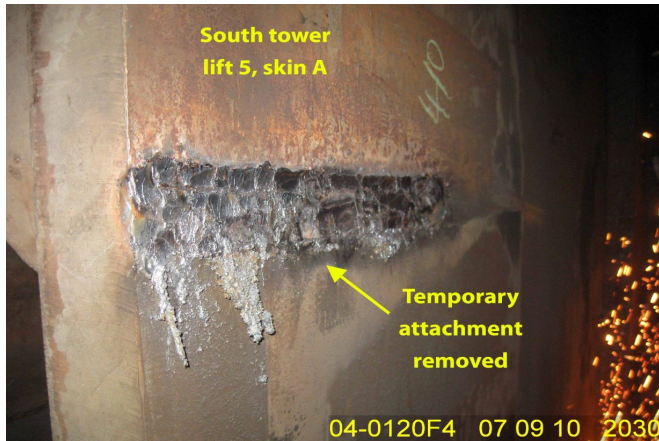
ZPMC personnel flame cutting and air-carbon-arc gouging of temporary attachments from PCMK south tower, lift 5, skin A, several areas. See photo below.
